Illinois Commerce Commission

Assessment of

MidAmerican Energy Company's

For Calendar Year 2004

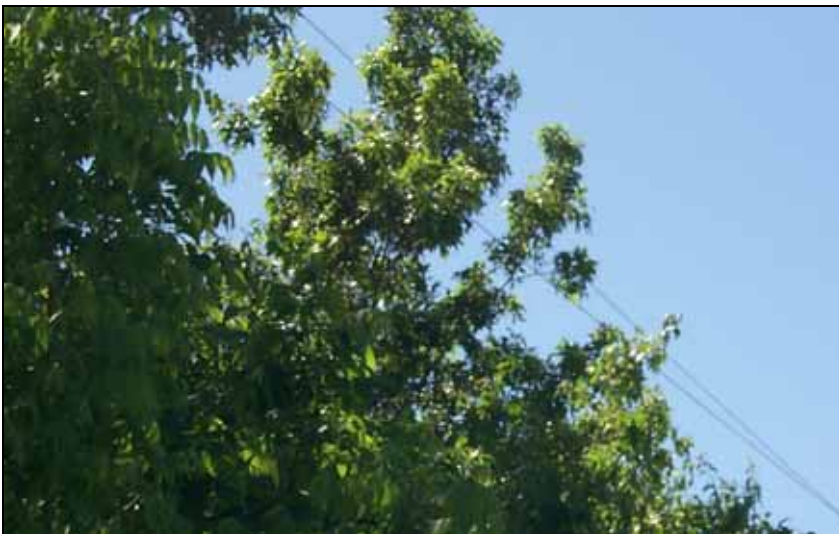
Staff's 2005 inspection identified several locations where threats to reliable service were visible. For example, during its inspection, Staff noted several locations where trees were contacting or very close to the conductor (Photos 1 & 2).

Photo 1: Tree grown between primary and neutral wires (13-104-2)

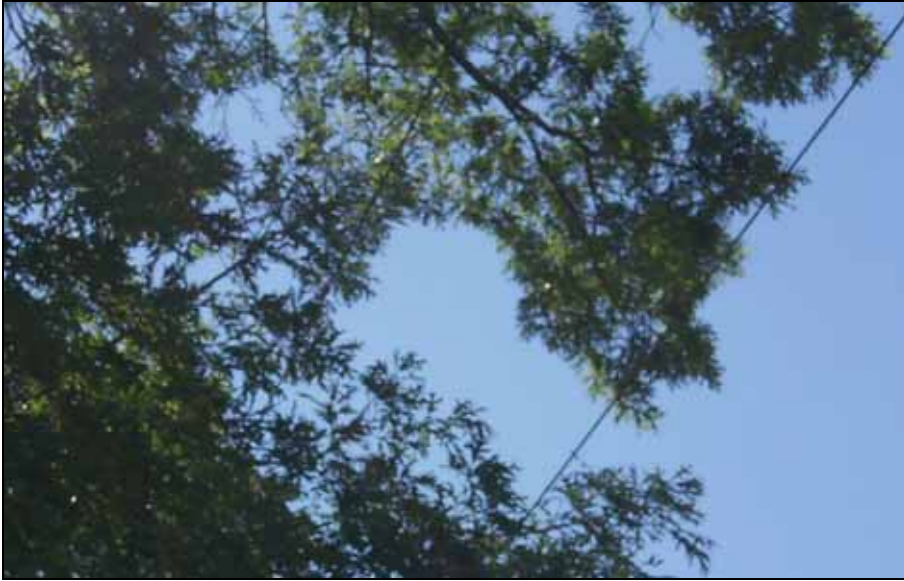
Photo 2: Oak tree contacting primary conductor (13-104-2)

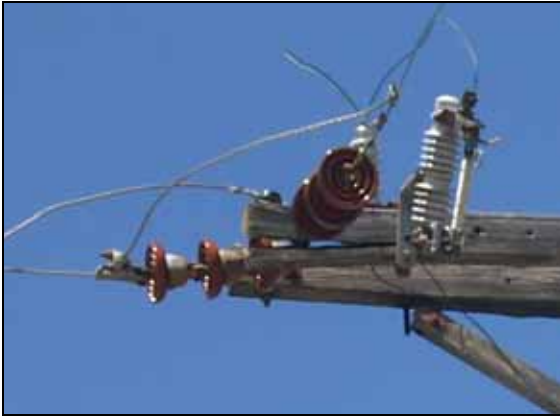
Staff also noted more than a dozen locations where pole tops and/or cross arms were splitting or deteriorated (examples shown in Photos 3-6).

Photo 3: Split arm (13-104-2)

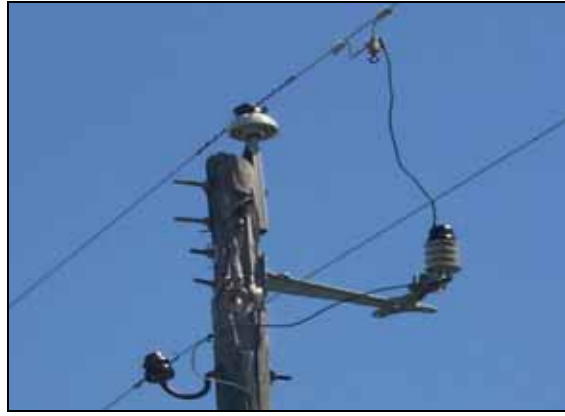
Photo 5: Damaged pole top (13-104-2)

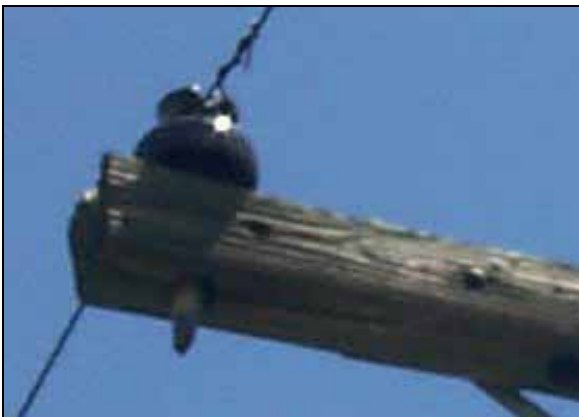
Photo 4: Split arm & fallen pin (13-104-2)

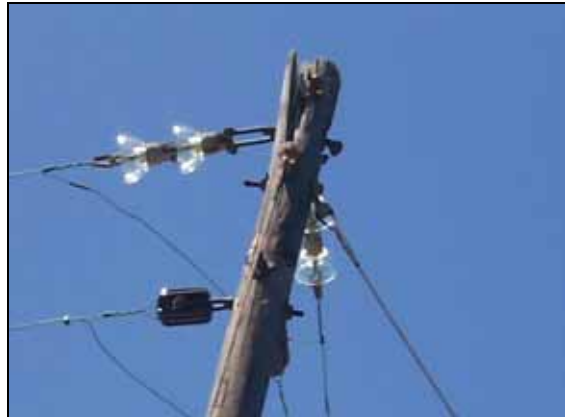
Photo 6: Splitting pole top (13-104-2)

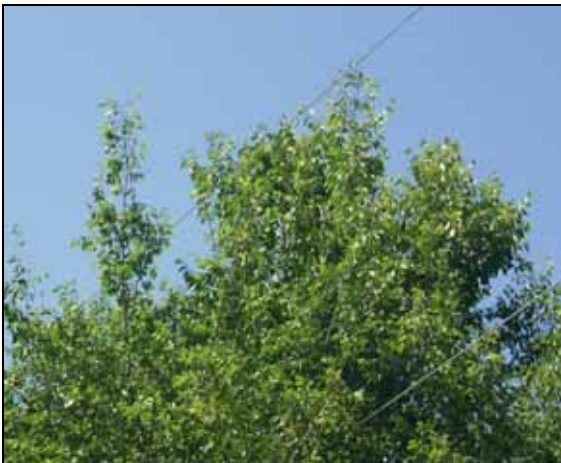
Photo 7: Tree through primary (13-38-3)

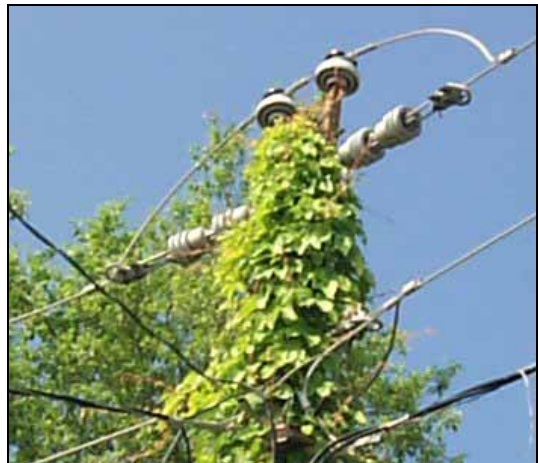
Photo 8: Vines to primary (13-38-3)

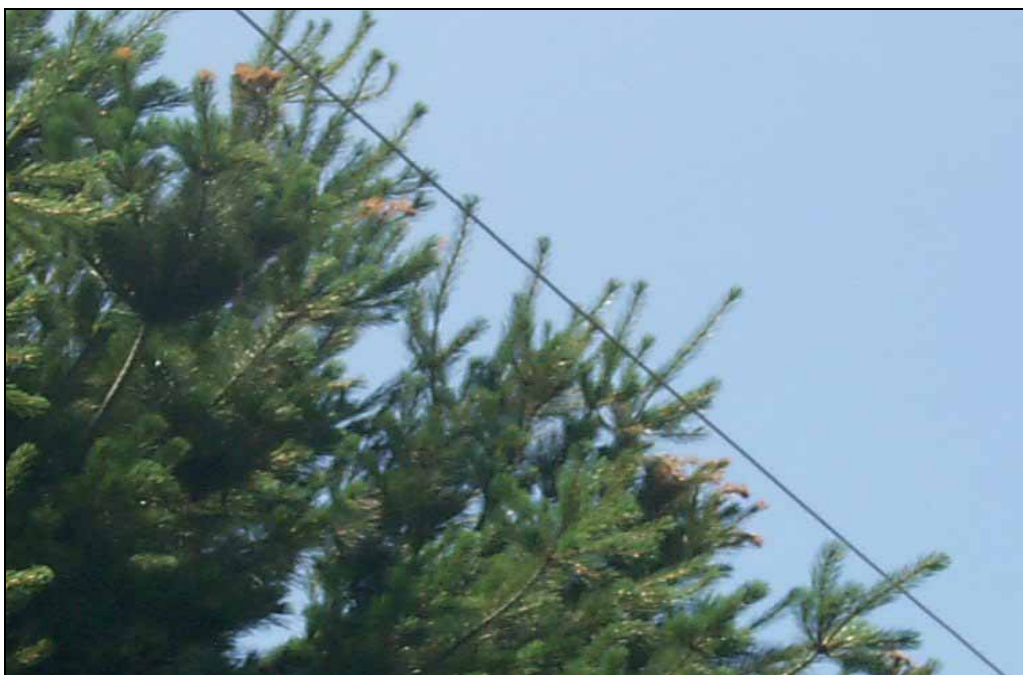
During its inspection of Circuit 13-46-1 Staff noted trees contacting the primary at five separate locations (Photo 9), and noted other problems at 4 additional locations: a failing cross arm (Photo 10); a loose pole-top pin; two lightning damaged poles (Photo 11); and primary that had been dead-ended without any guying. Staff also noted that animal guards had been installed on some, but not all, of the overhead distribution transformers in residential neighborhoods that seemed likely to support a squirrel population.

Photo 9: Pine with tips of branches burning on primary (13-46-1)

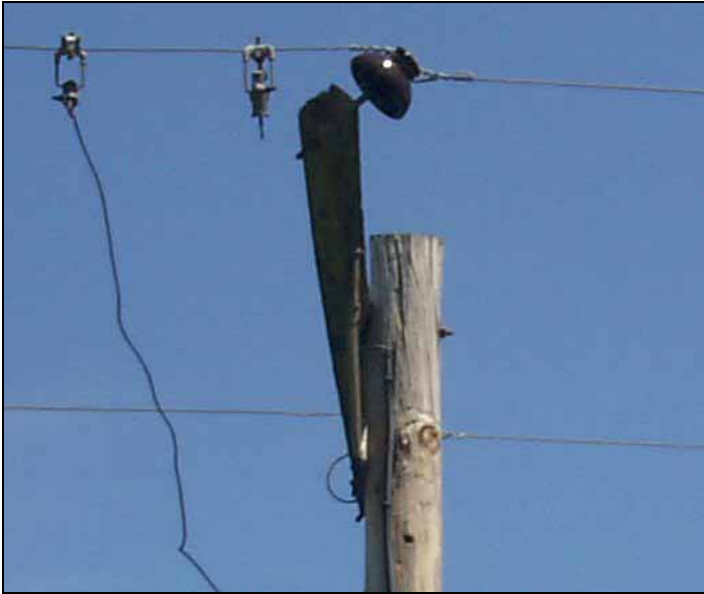
Photo 10: Failing cross arm (13-46-1)

| Summary of Distribution Circuit Field Inspection by ICC Staff | | | |
|---|--|---|--|
| 9 | Failing cross arm | 2 | Tap W/Friendship Farm Rd -near end/Jean St. |

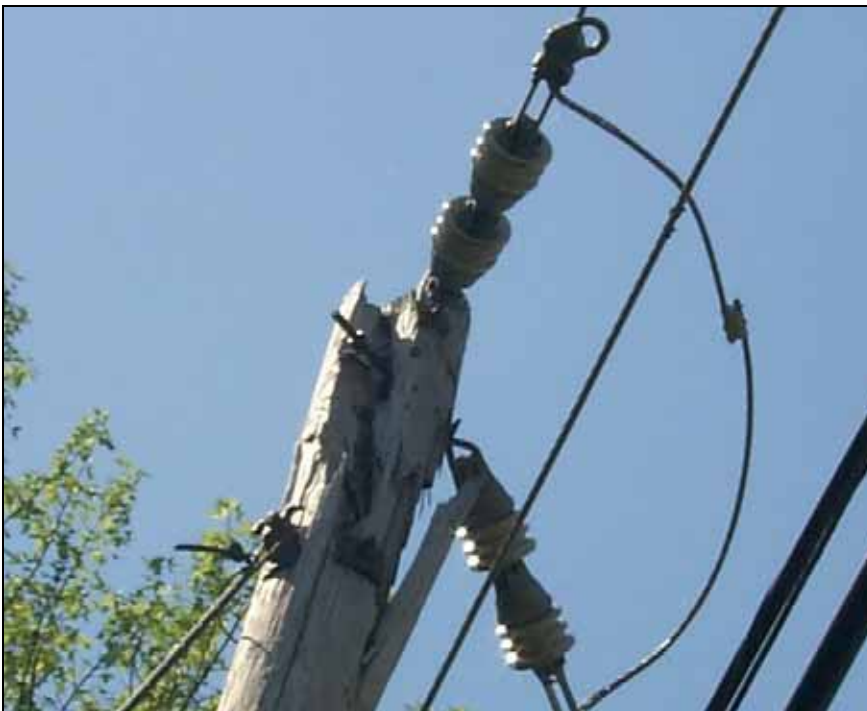
Photo 11: Pole top damaged by lightning (13-46-1)

| Summary of Distribution Circuit Field Inspection by ICC Staff | | | |
|---|--|---|--|
| 4 | 2 poles with apparent lightning damaged | 3 & 4 | River Rd S/Coal Town Rd. -where road turns west at |

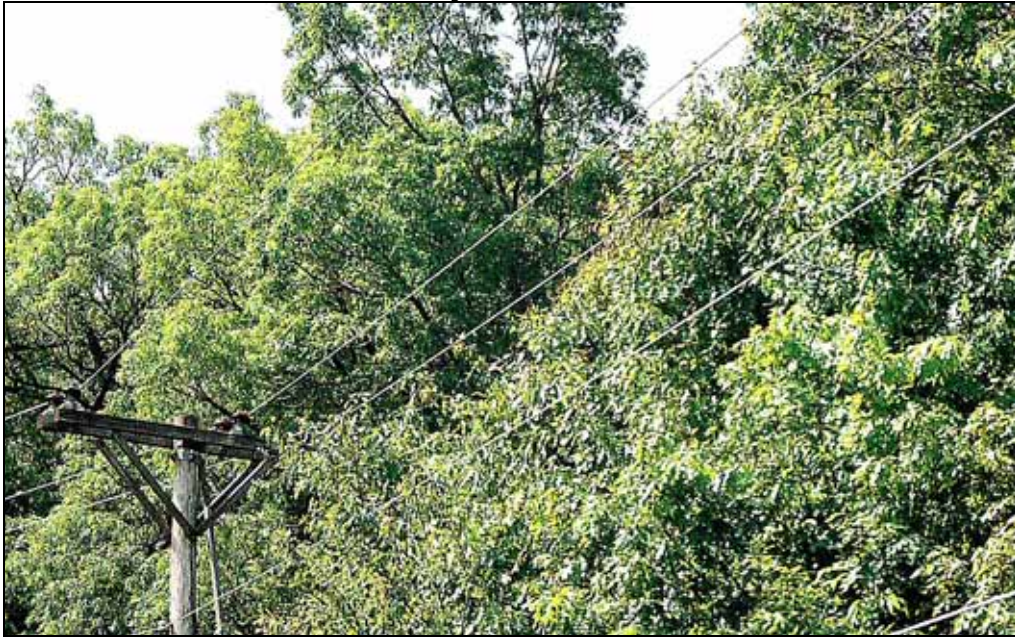
Figure 1 (Photo 05K19)

**3-phase primary burning oak trees
17th St. at entrance to Trinity West Medical Center, Rock Island**

| Summary of Tree Conditions Field Inspection by ICC Staff | | | |
|---|--|---|---|
| | 3-phase primary burning oak trees | K19, K20 | 17th St. at entrance to Trinity West Medical Center |

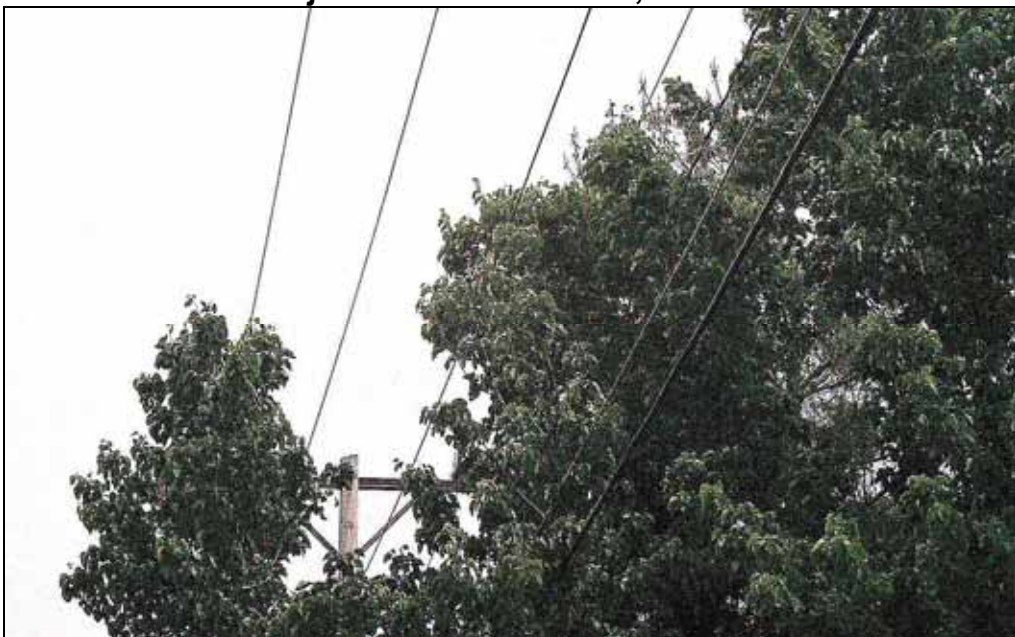
Figure 2 (Photo 05K24)

**Trees growing into primary
38th St. just north of 11th Ave., Rock Island**

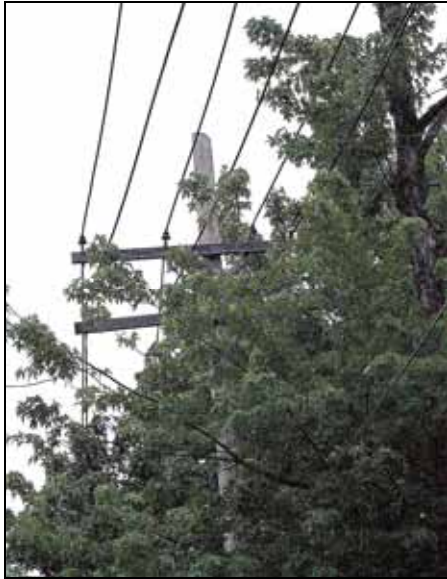
Figure 3 (Photo 05L11)

**Soft maple trees into and through 3-phase primary
14th St. between 17th & 18th Aves., Moline**

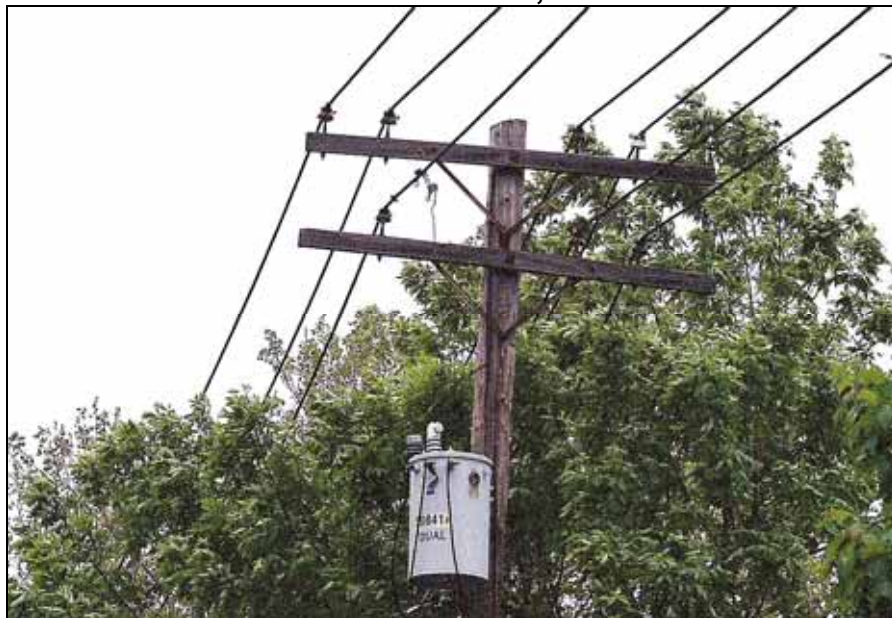
Figure 5 (Photo 05L13)

**Ash trees into and through 3-phase primary
14th St. at 17th Ave., Moline**

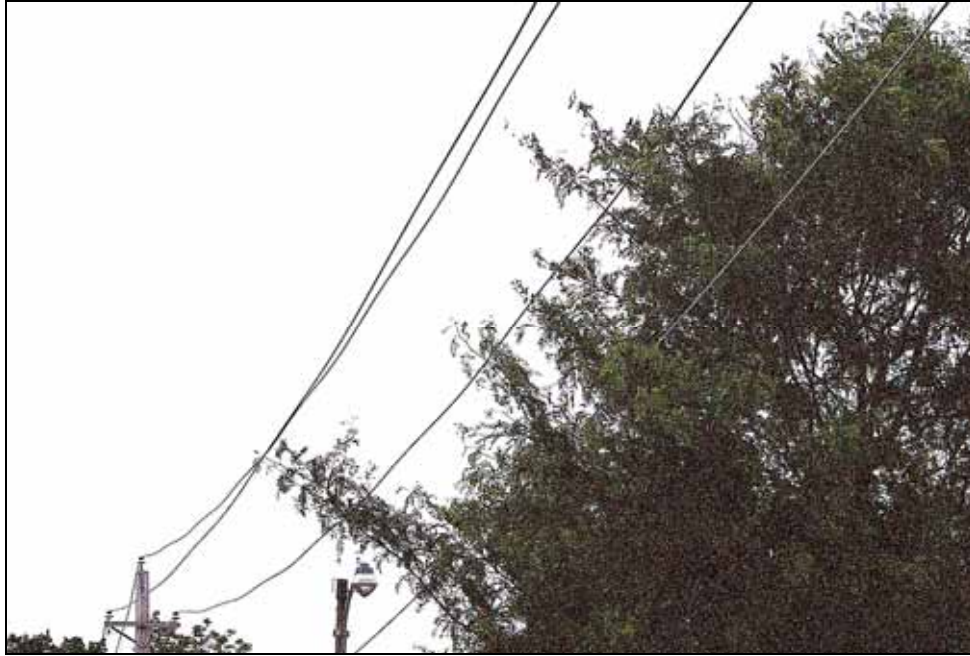
Figure 6 (Photo 05L17)
Tree into 3-phase primary, with burning
21st St. just north of 5th Ave., Moline

| Summary of Tree Conditions Field Inspection by ICC Staff | | | |
|---|--|---|---|
| | Tree into primary, with burning | L17 | 21st St. just north of 5th Ave. |

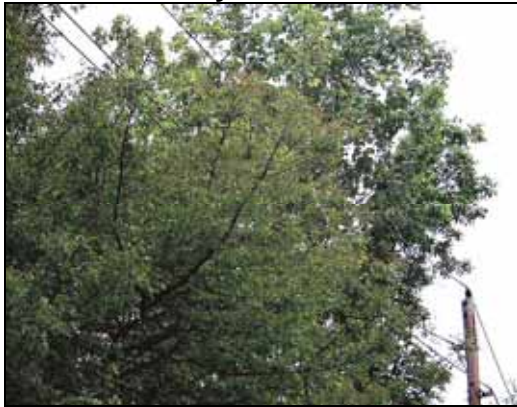
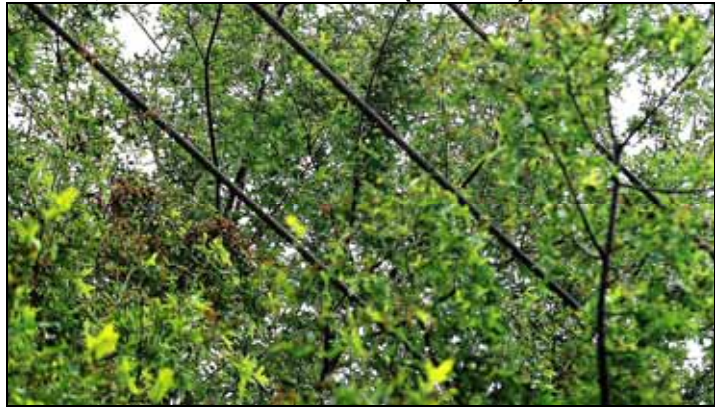
Figure 7 (Photo 05L19)

Oak tree burned by 3-phase primary
In the alley between 33rd & 34th Aves., west of Sunset Dr. (53rd St.), Moline

| Summary of Tree Conditions Field Inspection by ICC Staff | | | |
|---|--|---|---|
| | Oak tree burned by 3-phase primary | L19, L20 | In the alley between 33rd & 34th Aves., west of Sunset Dr. (53rd St.) |

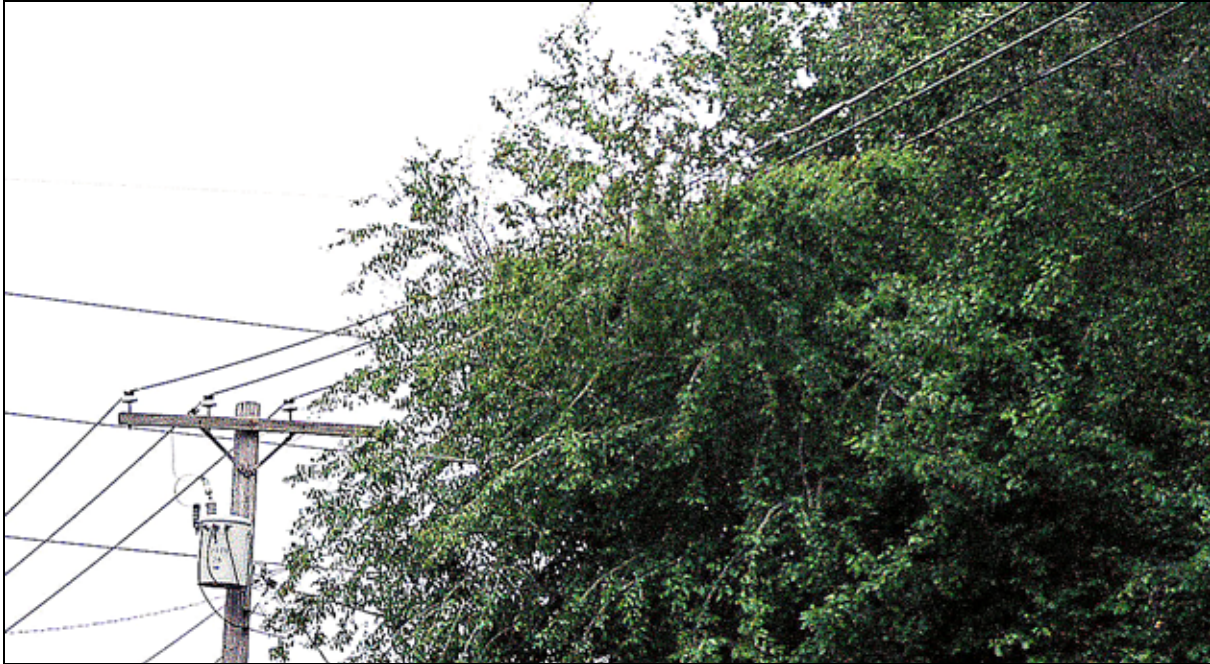
I noted tree contacts with MEC's primary at only two locations in East Moline, with a few other close locations noted. Tree trimming looked good in Silvis, with only one close clearance location noted. Figure 9 shows one of the tree conflicts in East Moline.

Figure 9 (Photo 05L23)
3-phase primary “electrotrimming” tree
19th St. south of 9th Ave., East Moline
